Navajo Abandoned Uranium Mine

Site Screen Report

Lemuel Littleman No. 3 AUM Site

January 2011

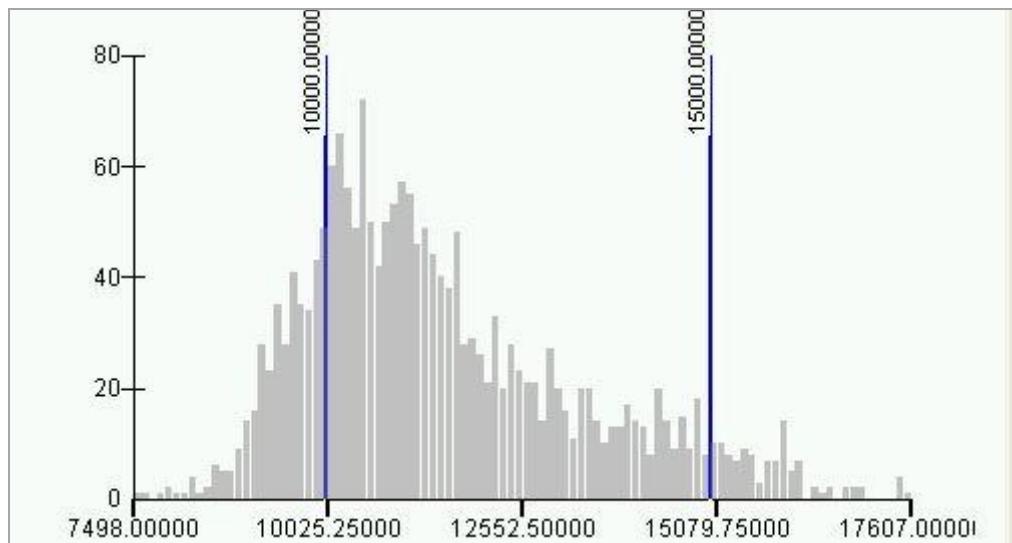
Distribution Chart and Statistics:

The following chart and statistics were generated by ESRI ArcGIS 9.3.1, and show the general distribution of the site gamma radiation measurements. The horizontal X axis represents the gamma radiation reading levels in cpm (lowest levels to the left). The vertical Y axis represents the frequency of each gamma radiation level.

Count:	1944
Minimum:	7498.00000
Maximum:	17607.00000
Sum:	22372235.00000
Mean:	11508.35134
Median:	11085.00000
Standard Deviation:	1798.73255

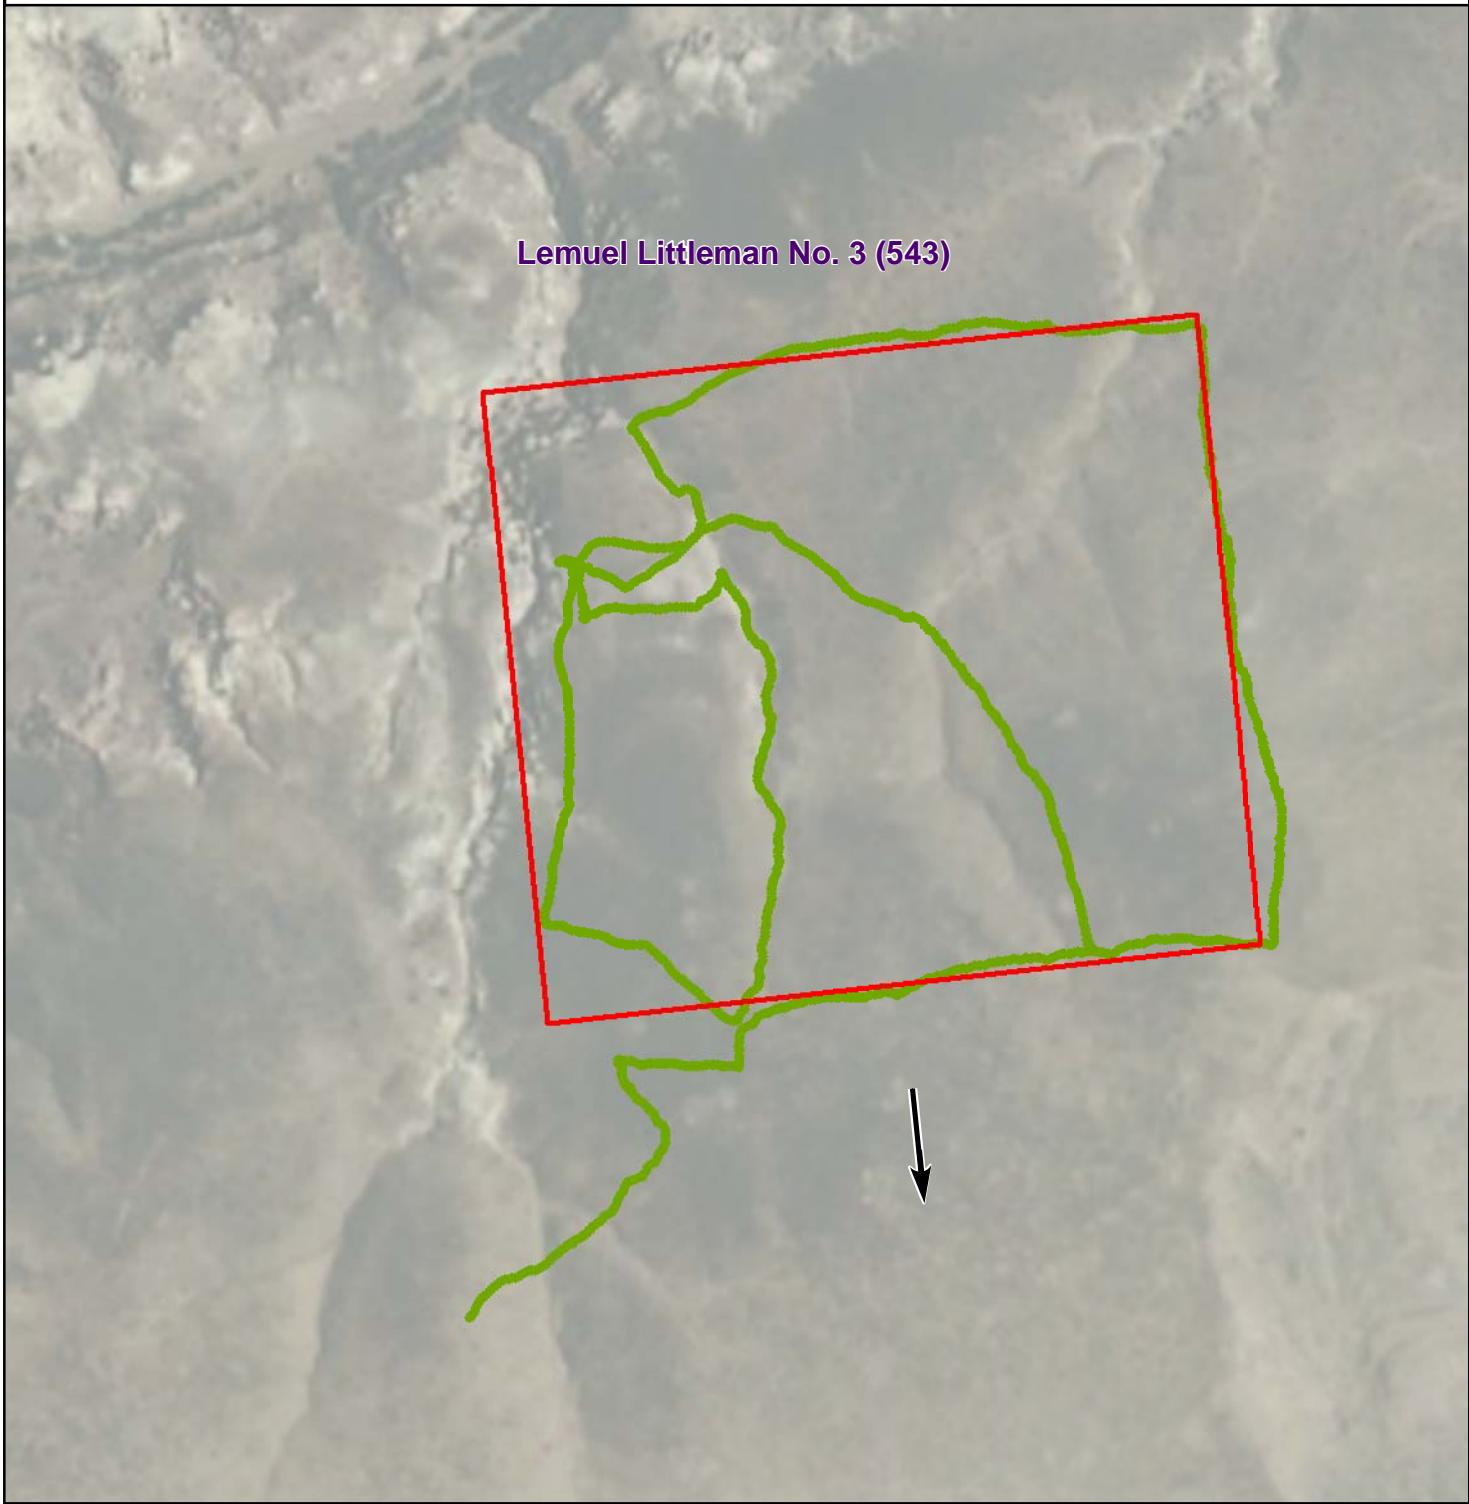
Figure 1 - Gamma Radiation Measurements, Above Two Times Background
Lemuel Littleman No. 3 (543)
Cameron Chapter, Navajo Nation

A total of 1,944 gamma radiation measurements were collected from the mine site, ranging from 7,498 cpm to 17,607 cpm. The measurements are represented in Figures 1 and 2.

Were any gamma radiation measurements collected at the mine greater than two times the site-specific background levels?

No

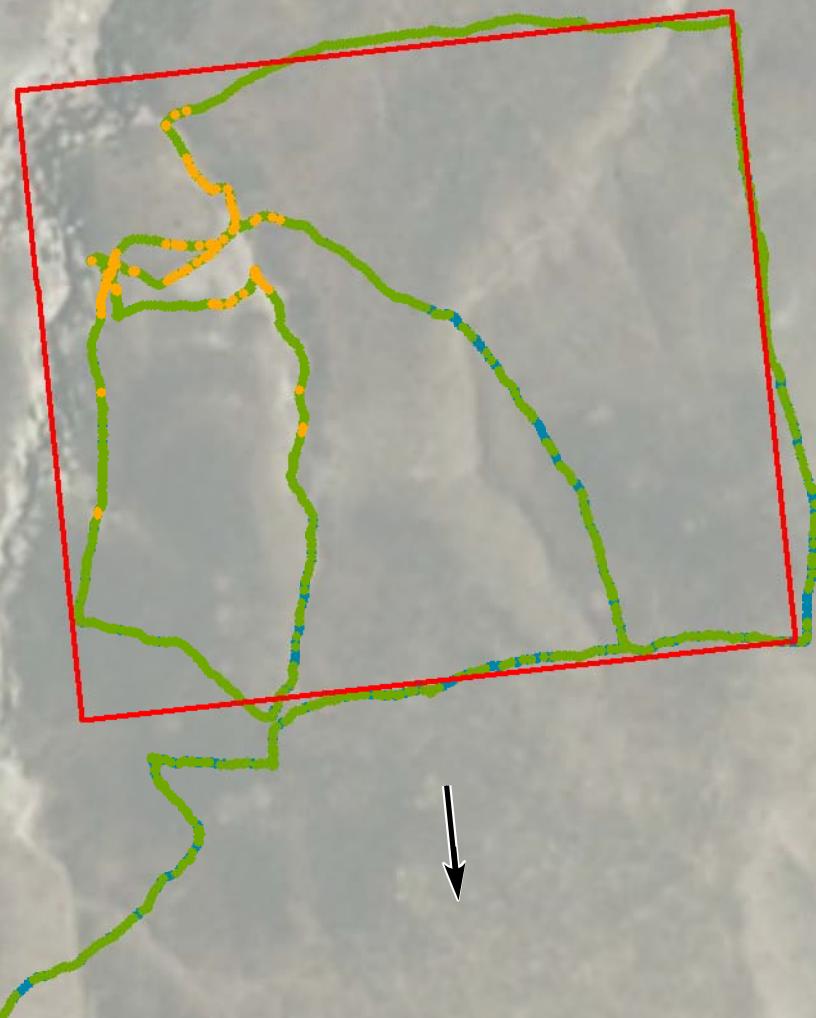
Figure 2 - Gamma Radiation Measurements
Lemuel Littleman No. 3 (543)
Cameron Chapter, Navajo Nation

17,607 counts per minute (cpm)
